**DEMOLITION TO 16 FAIRVIEW APARTMENTS
NC 15-1**

**OWNER PROVIDED
ASBESTOS
AND
LEAD BASED PAINT
REPORTS**

- **Fairview Apartments 15-1, Buildings 906, 908, 920 and 922 Fairview Circle
Lead-Based Paint Testing Report – OSE Project #23-1155 – (*Page 6041C HM-4*)**
by One Source Environmental; Report dated October 13, 2023 (58 Pages)

- **Fairview Apartments 15-1, Buildings 906, 908, 920 and 922 Fairview Circle
Asbestos Inspection Report – OSE Project #23-1155 – (*Page 6041C HM-62*)**
by One Source Environmental; Report dated September 18, 2023 (48 Pages)

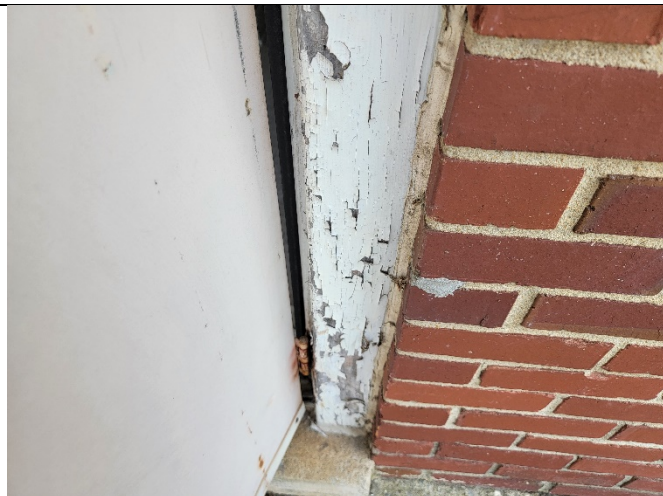
**Original LBP Wood Door Casing/Jamb
(often below Aluminum)**

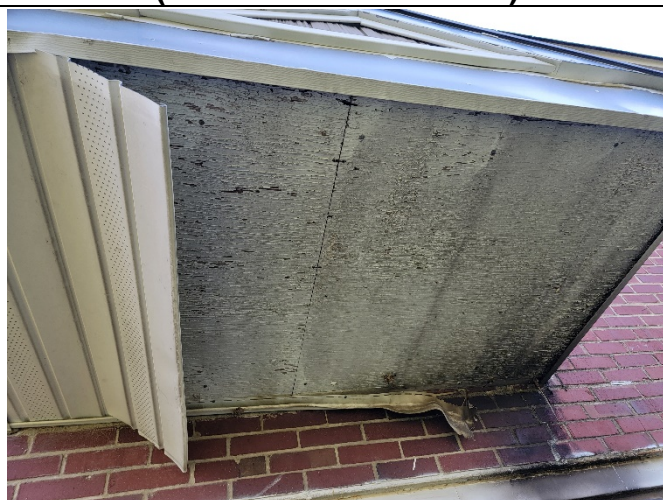
LBP Wood Porch Ceiling (often under Vinyl)

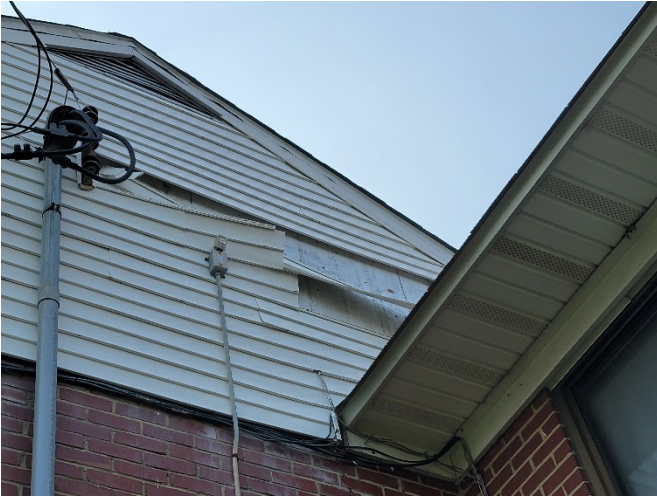
LBP Wood Gable (beneath Vinyl)

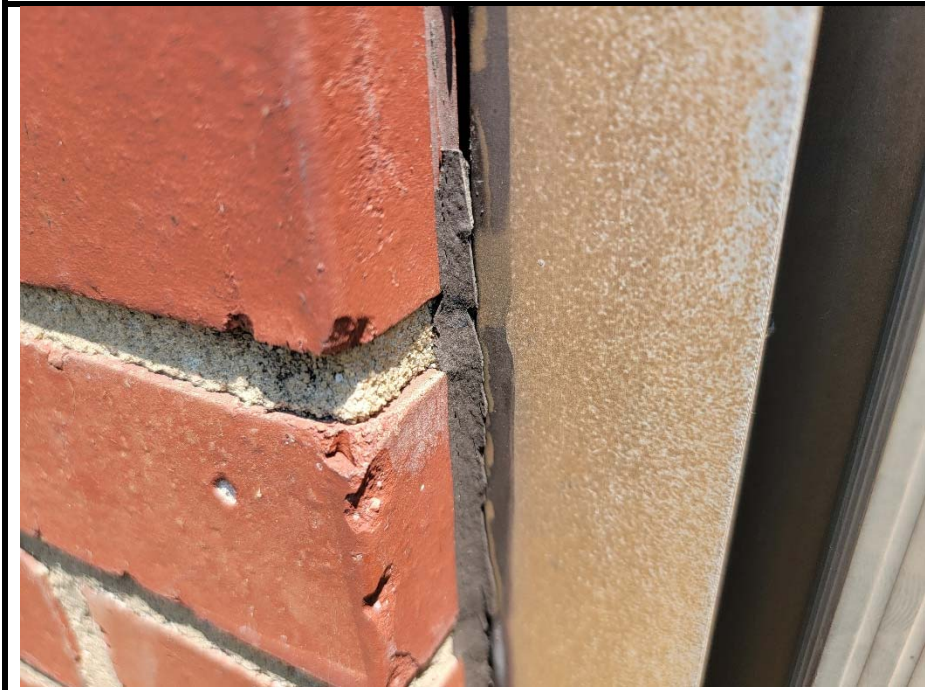
1. Non-ACM Exterior
Brown Window
Caulking

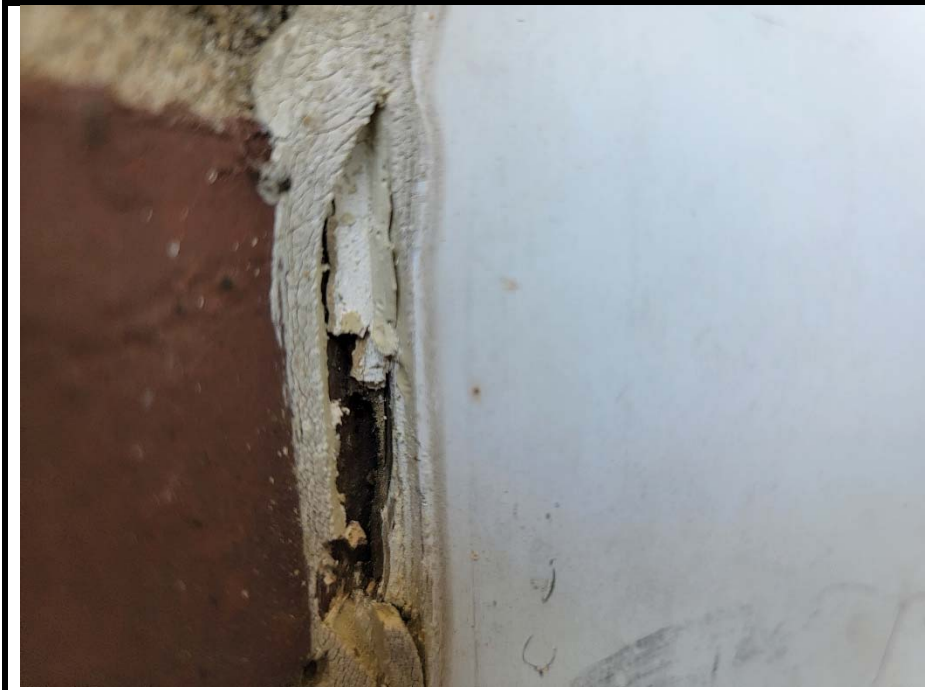
2. Non-ACM Exterior
White Door Caulking
over ACM Exterior
Gray Window Caulking

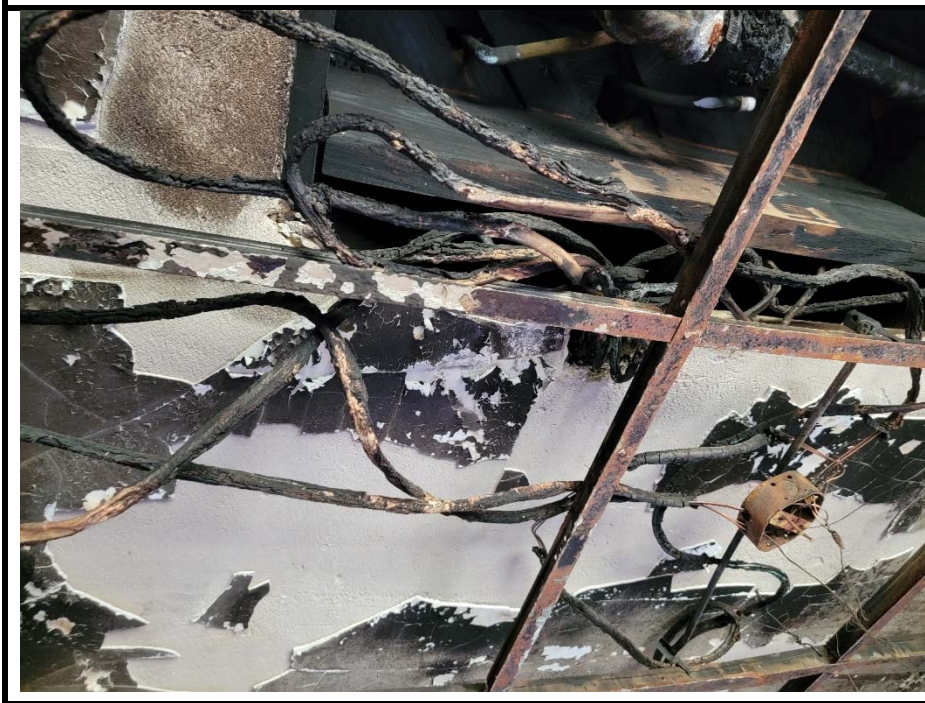
4. Non-ACM Plaster Ceiling

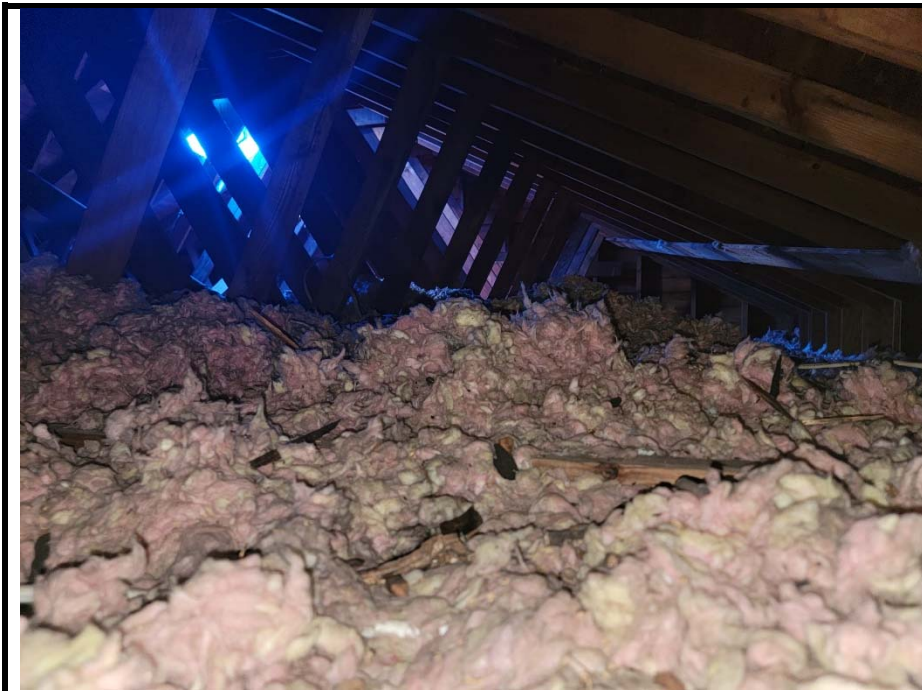
5. Fiberglass Fill Attic Insulation

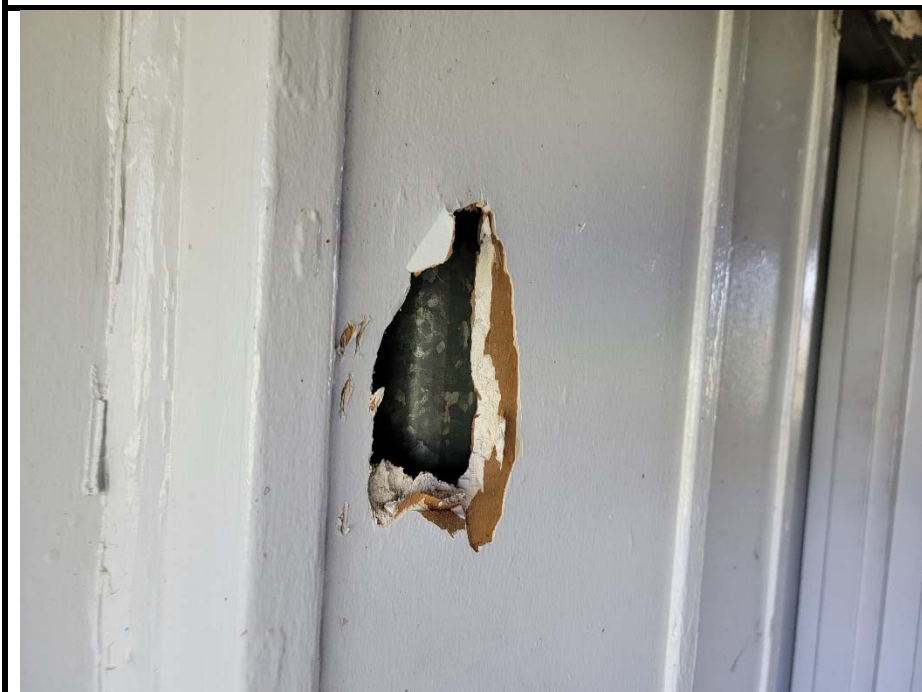
6. Non-ACM Drywall at Duct Chase

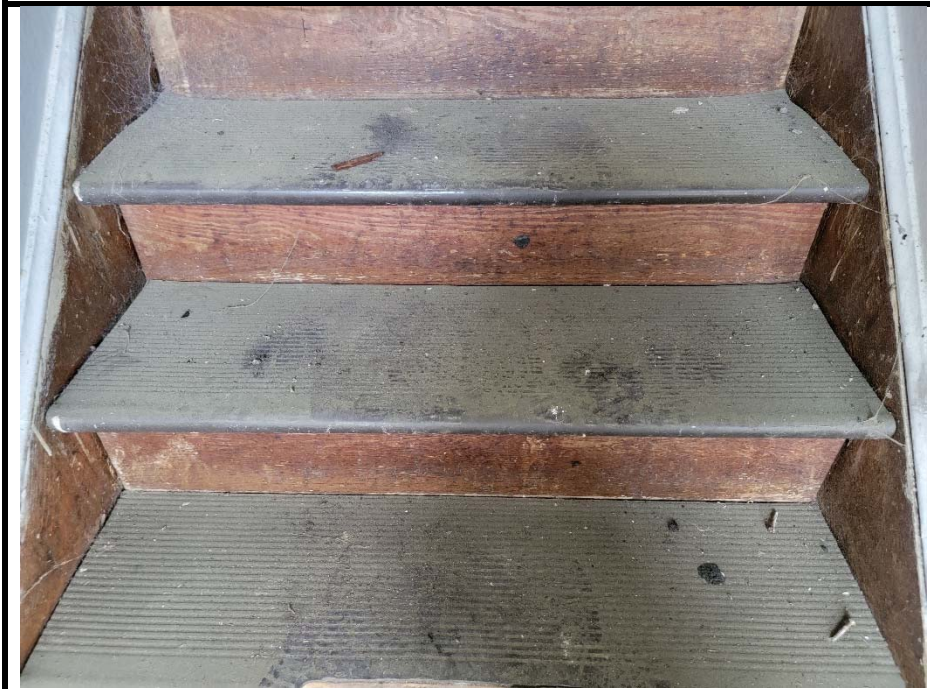
7. Non-ACM Brown Vinyl
Stair Tread

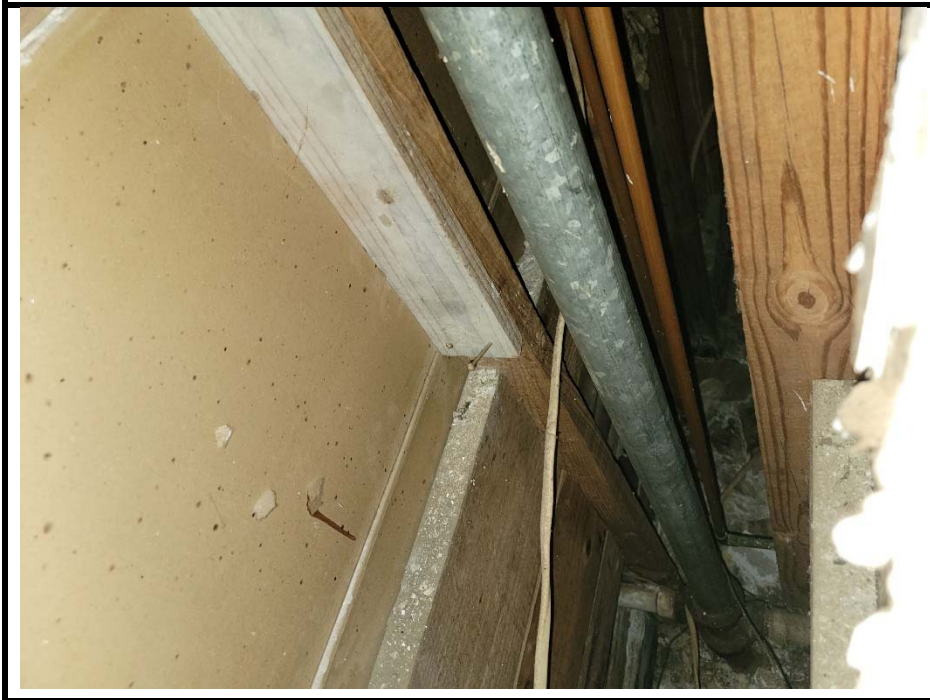
8. Non-ACM Plaster
Board Bathroom Walls

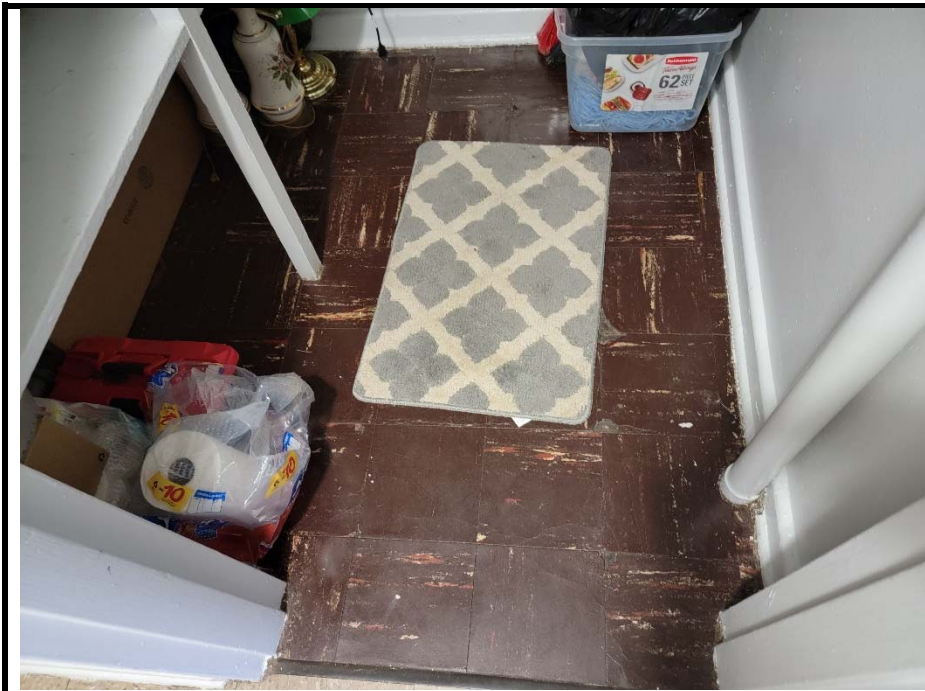
9. ACM 9"x9" Brown w/
White/Red Streaks
VFT over ACM Black
Mastic

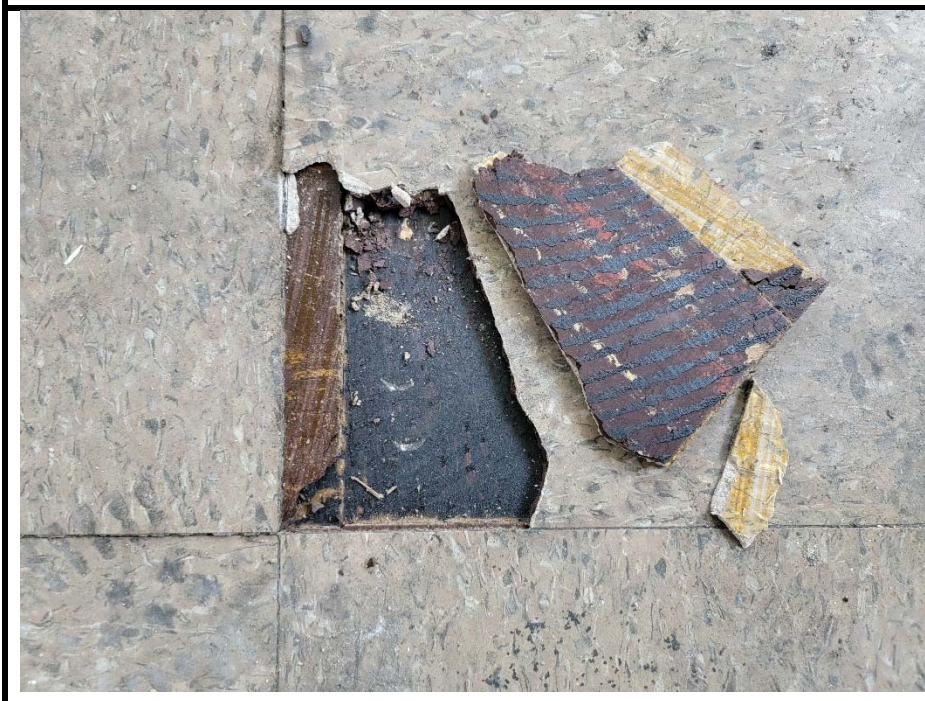
10. Non-ACM 12"x12"
Brown w/ White/Black
Flecks VFT over ACM
9"x9" Brown W/
White/Red Streaks
VFT

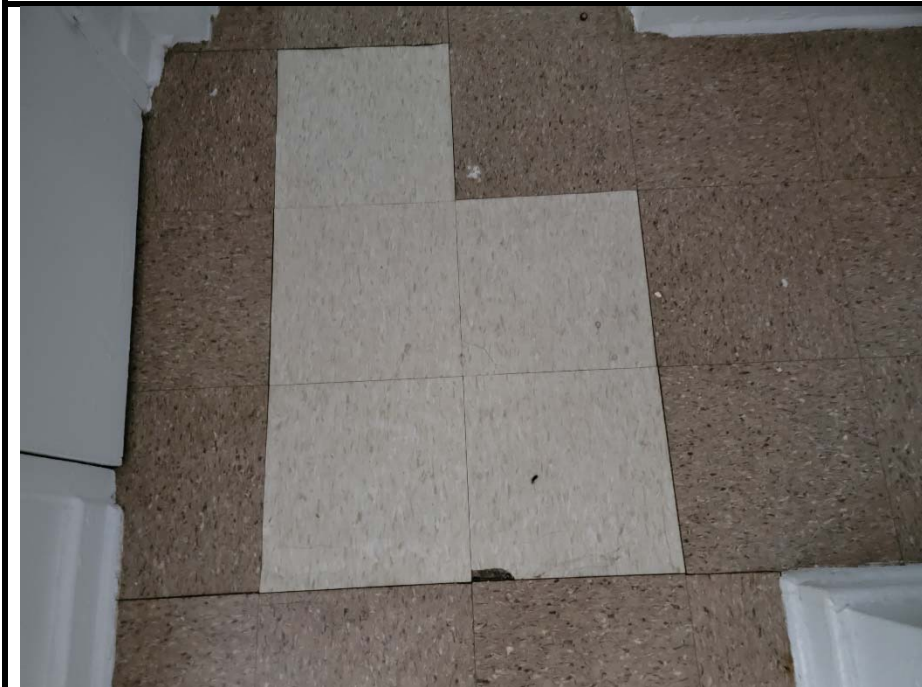
11. Non-ACM 12"x12"
White w/ Brown Long
Flecks VFT patch

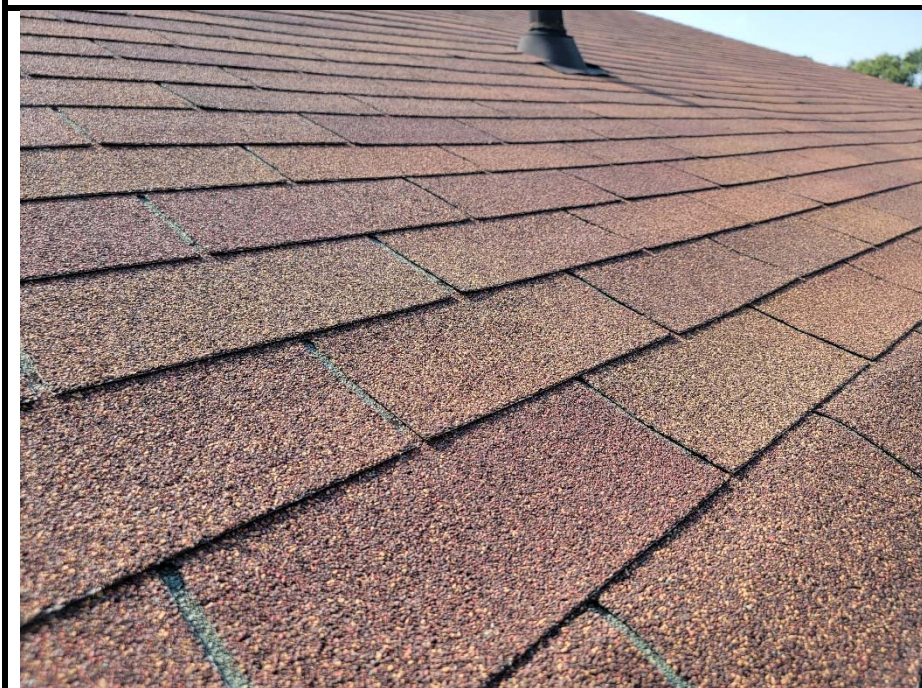
12. Non-ACM Asphalt
Shingle Type 1

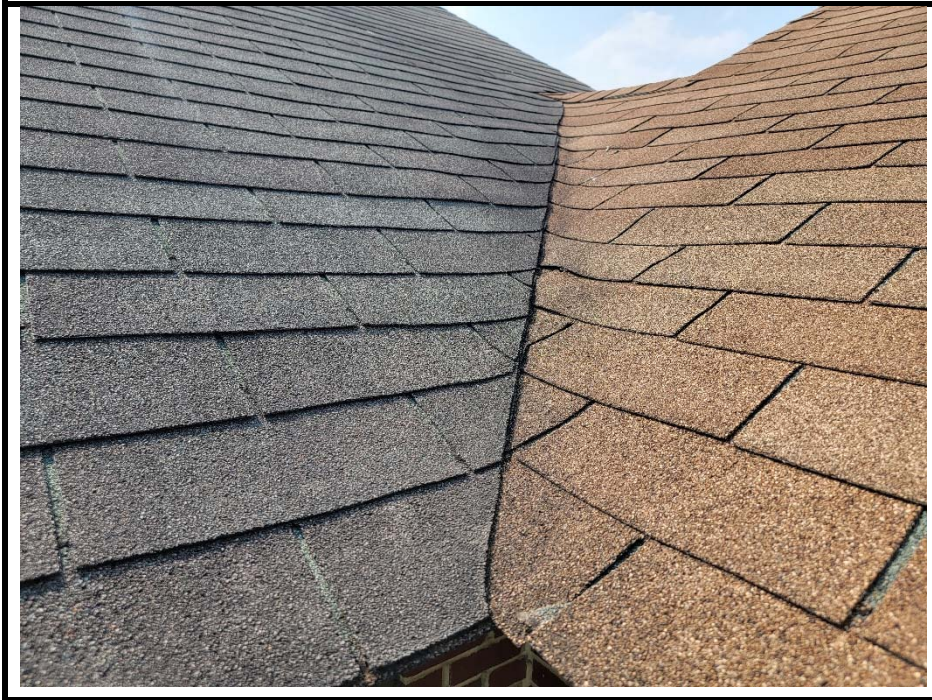
13. Non-ACM Asphalt Shingle Type 2 (left) & Non-ACM Asphalt Shingle Type 3 (right)
