ADDENDUM 2

PROJECT: Trexler Middle School Renovation & Site Improvements
112 E. Foy Street
Richlands, NC 28574

APPENDIX 1
Site Location Plan and Sample Location Plan

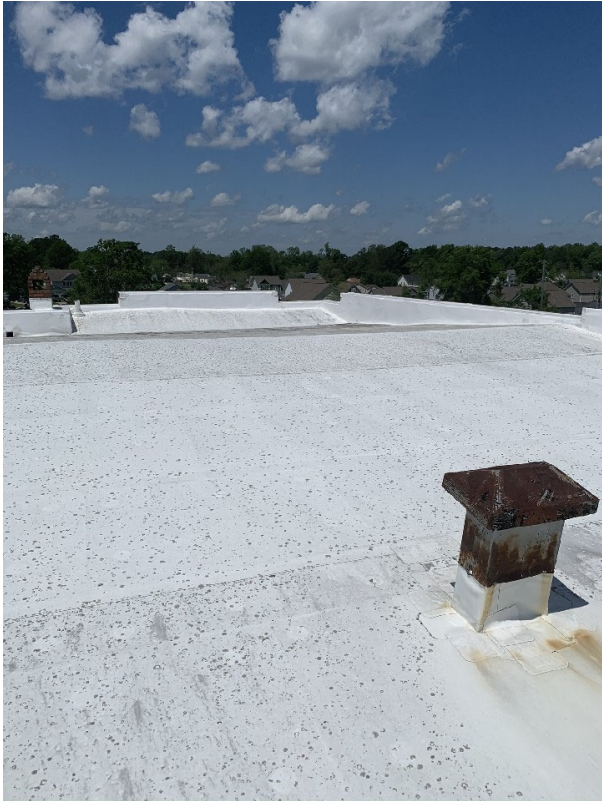
Roof, Building A TPO Membrane

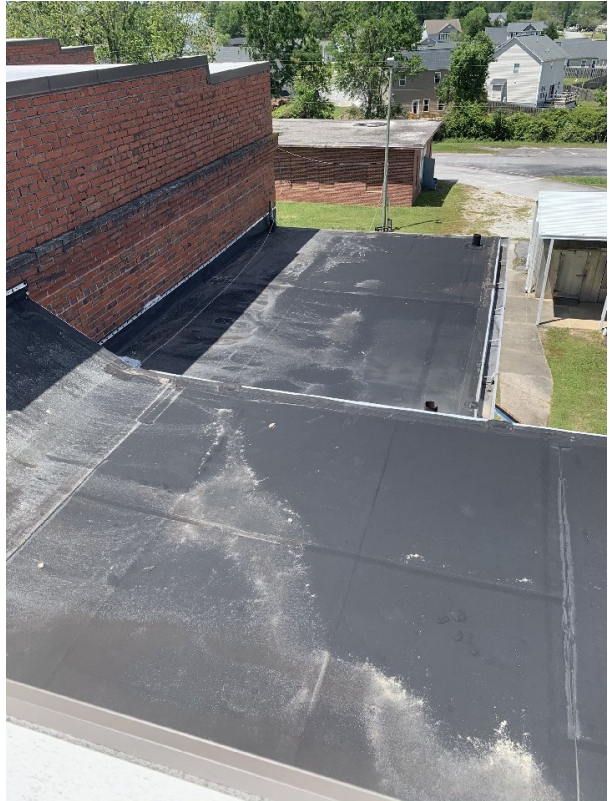
Roof, Building A EPDM Membrane

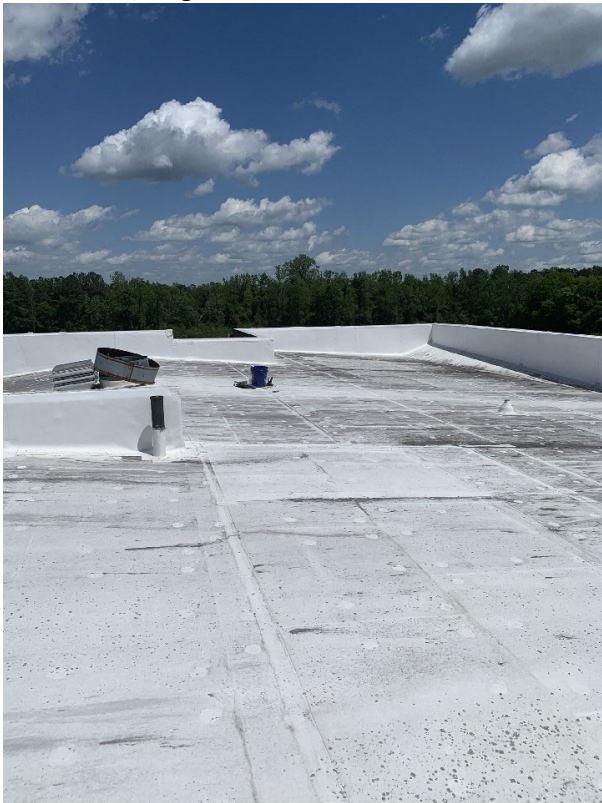
Roof, Building A TPO Membrane

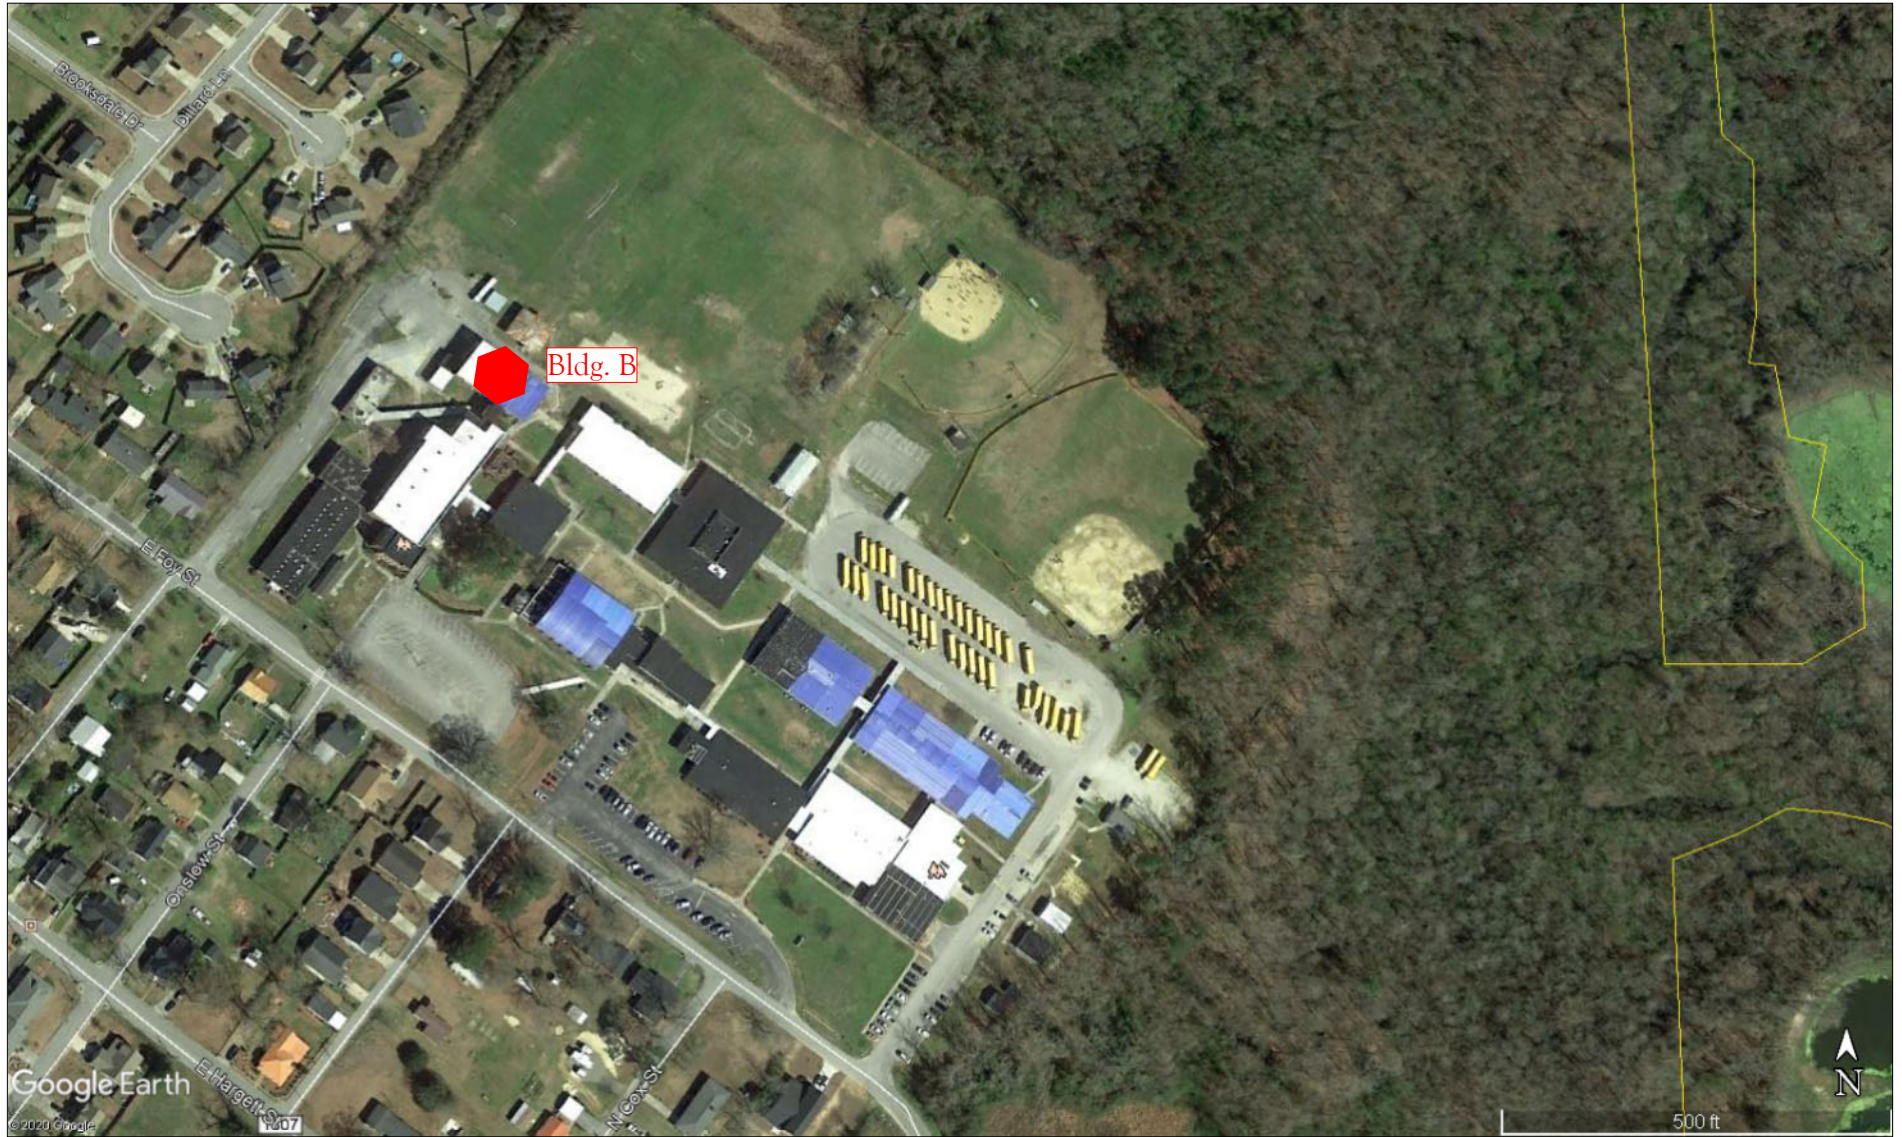
Figure 1

Site Location Plan
 Richlands Elementary School
 Building B
 Richlands, NC
 Project # - 2020-01-122

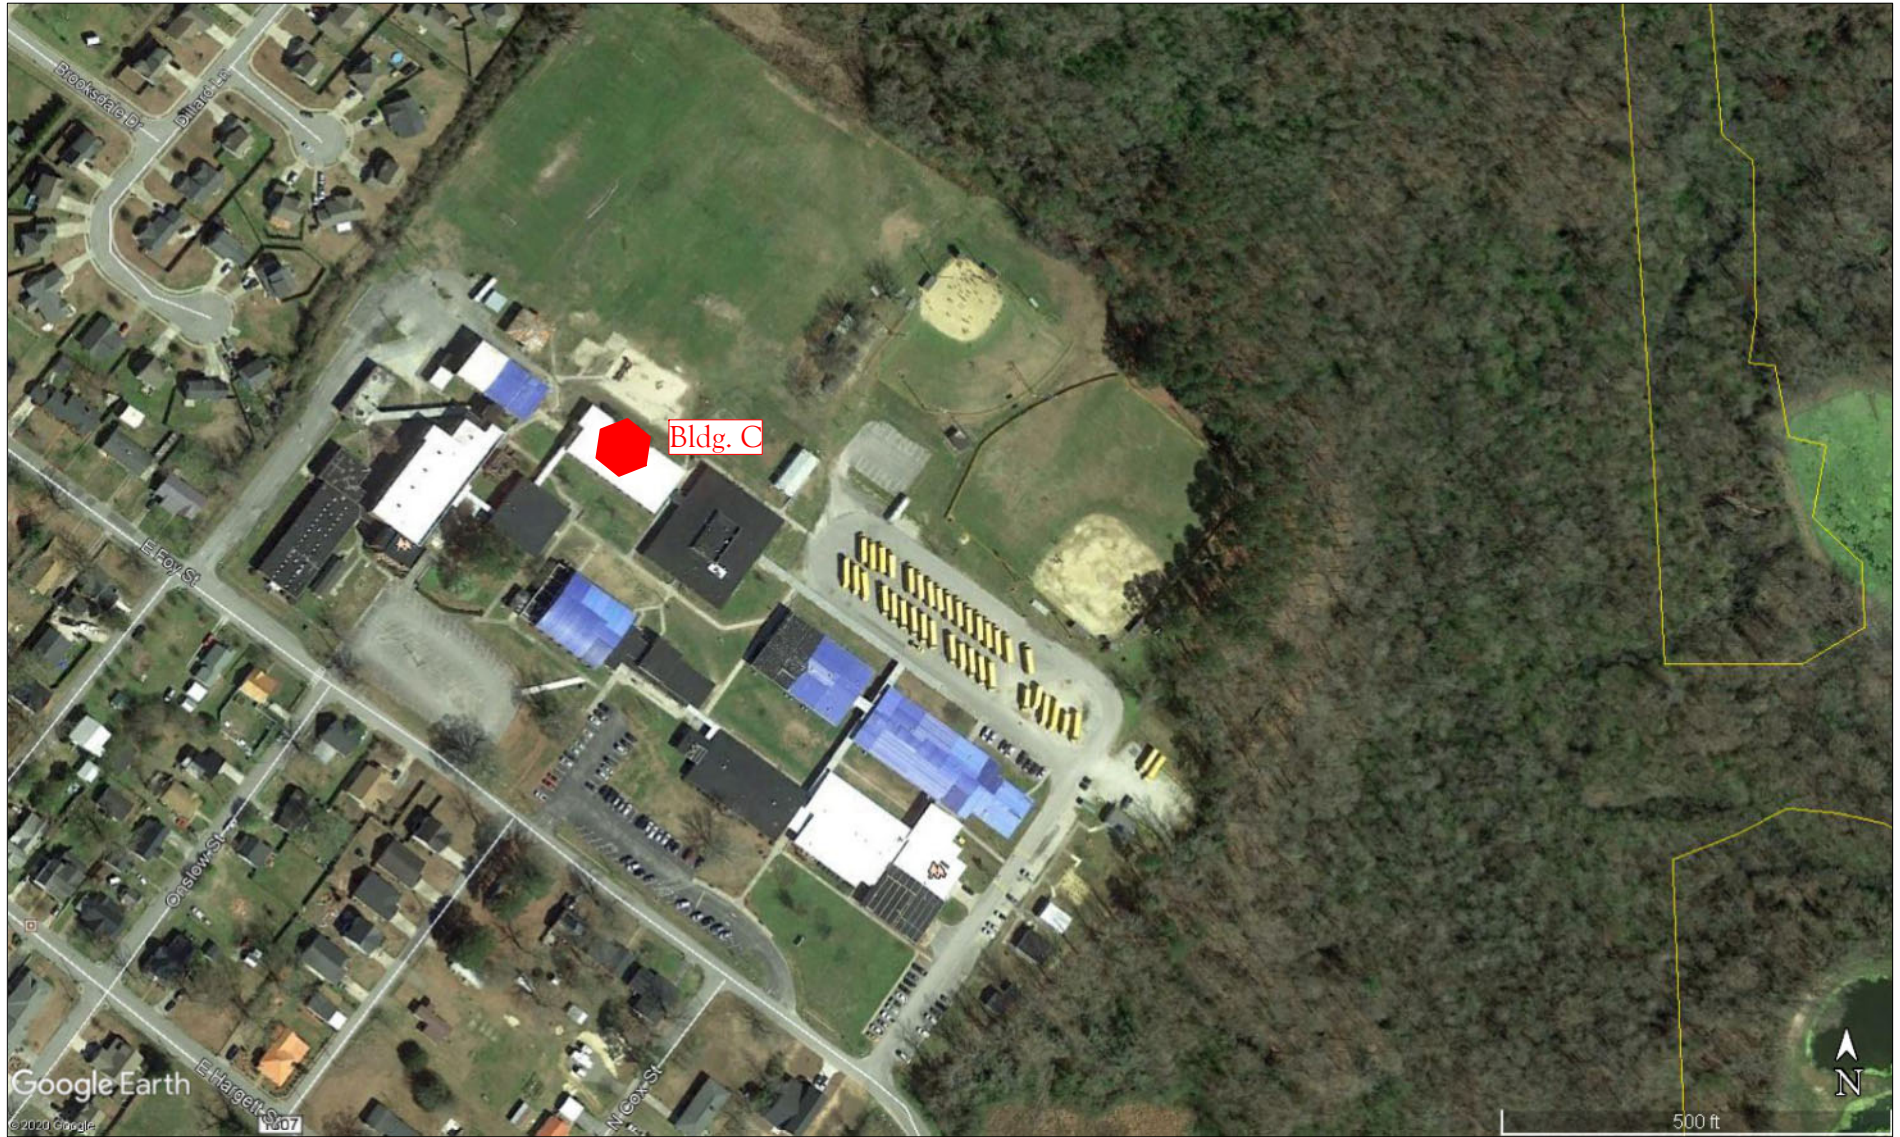
Figure 1

Site Location Plan
 Richlands Elementary School
 Building C
 Richlands, NC
 Project # - 2020-01-122

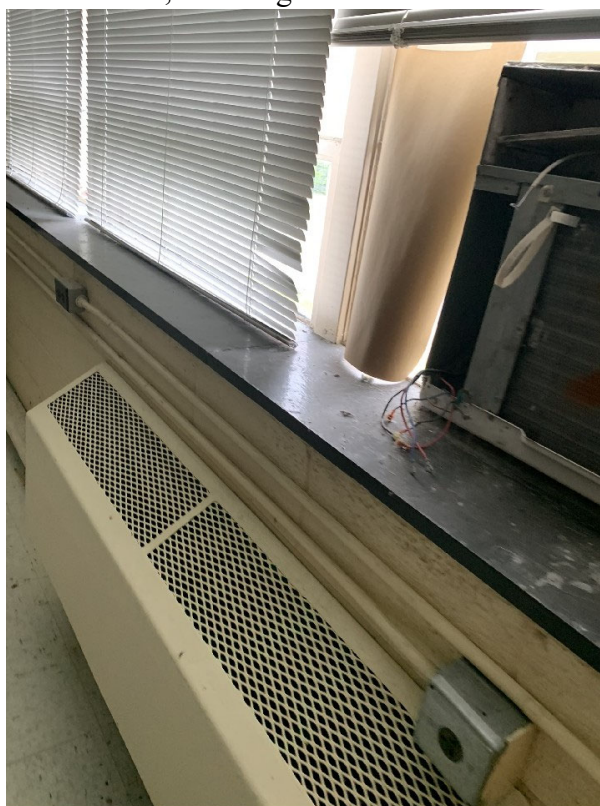
Interior Window, Building D

Material Id	Material	Space Name	Quantity	Material Category	Current Condition	Friability	Damage Potential	Physical Assessment Category
005	Caulk	Interior Window	50 sf	Miscellaneous	Damaged	Category II Nonfriable	Potential for Significant Damage	4
006	Black Wrap	Pipe	240 lf	Thermal System Insulation (TSI)	Good (No Damage)	Friable (RACM)	Potential for Significant Damage	6
007	Elbows	Pipe	1 Elbow, Possibly More	Thermal System Insulation (TSI)	Good (No Damage)	Friable (RACM)	Potential for Significant Damage	6
008	Peg Board Ceiling Tile	Ceiling Tile	7500 sf	Miscellaneous	Good (No Damage)	Friable (RACM)	Potential for Significant Damage	6
009	Black Floor Tile	Classrooms	800 sf	Miscellaneous	Good (No Damage)	Category I Nonfriable	Potential for Significant Damage	6
010	Tan Floor Tile	Classrooms	1570 sf	Miscellaneous	Good (No Damage)	Category I Nonfriable	Potential for Significant Damage	6
011	Gray Sheet Floor	Classrooms	35 sf	Miscellaneous	Good (No Damage)	Category I Nonfriable	Potential for Significant Damage	6

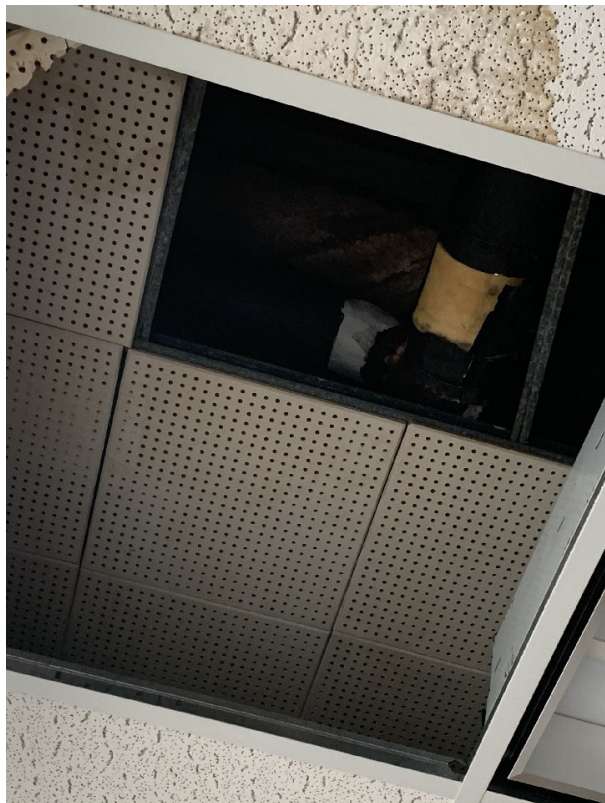
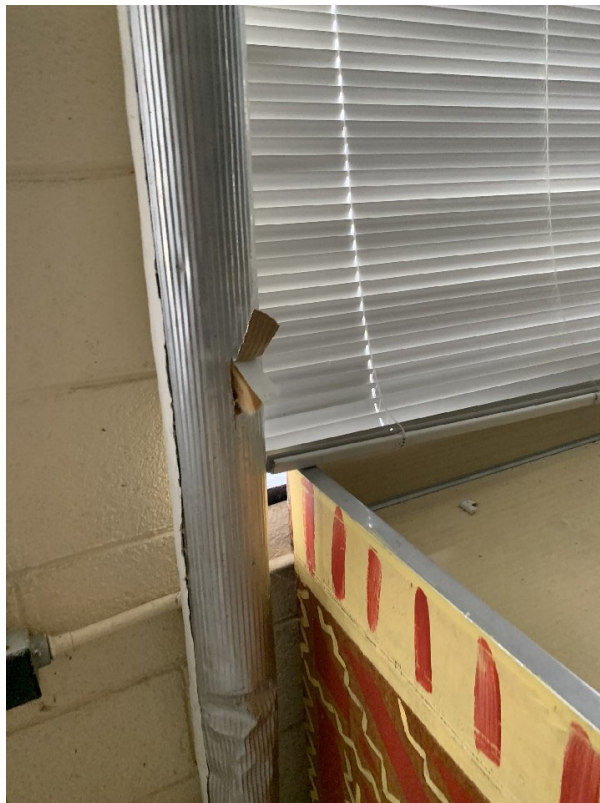
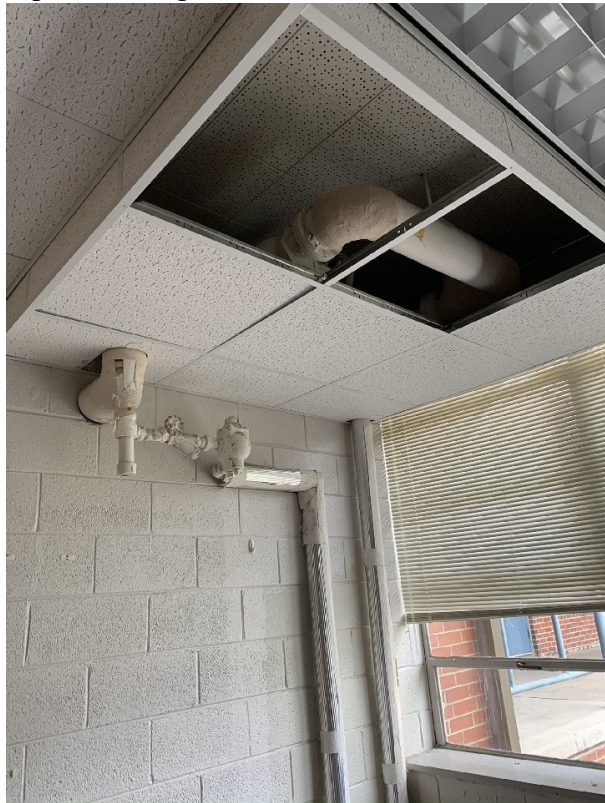
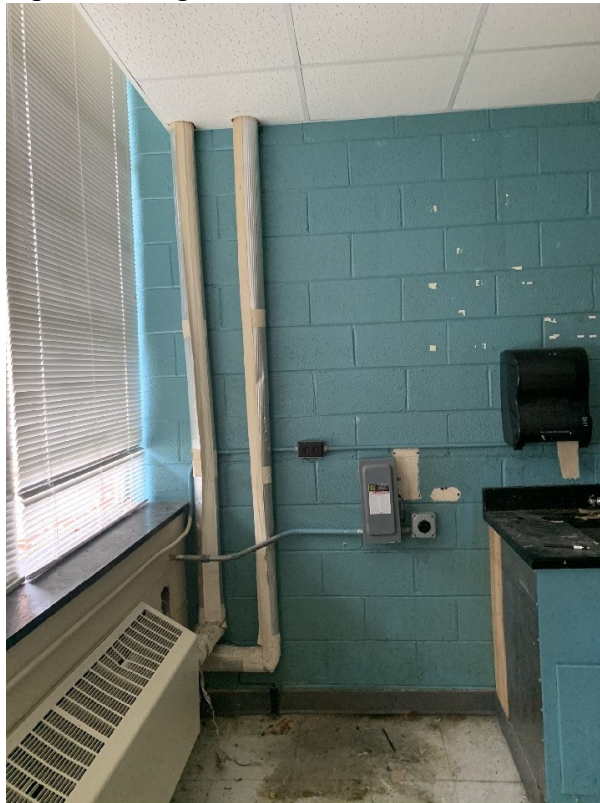
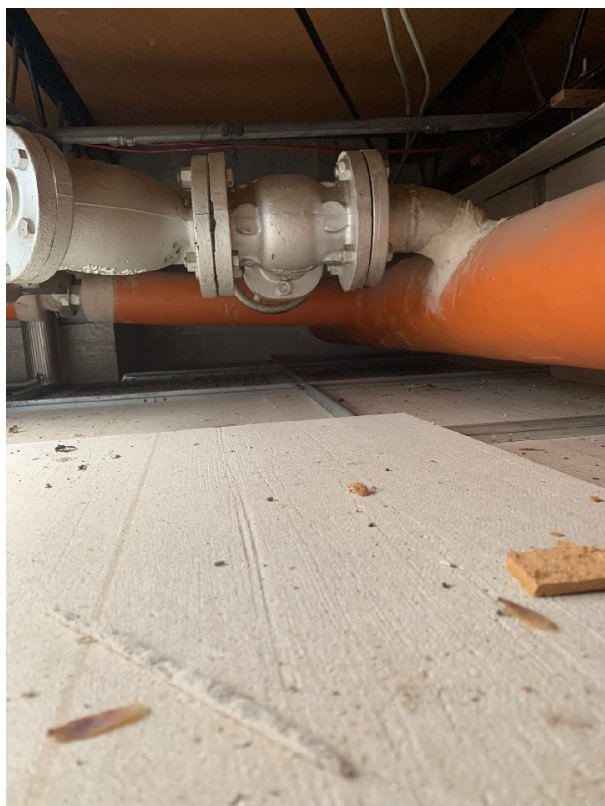
Pipe, Building D

The above identified ACMs should be removed by a properly licensed asbestos abatement contractor prior to demolition. The above identified floorings are in good condition and can most likely be removed in a non-friable manner. However, asbestos air monitoring will be required for any friable abatement work (i.e. pipe insulation).

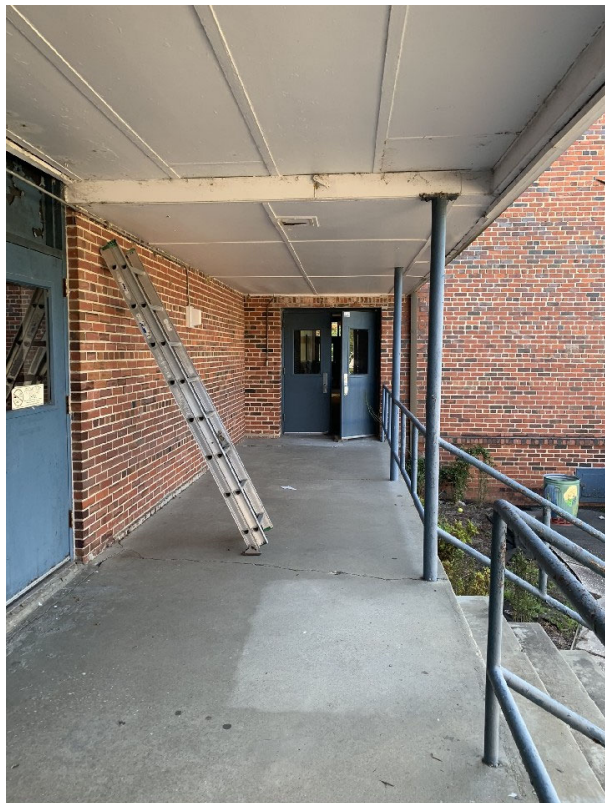
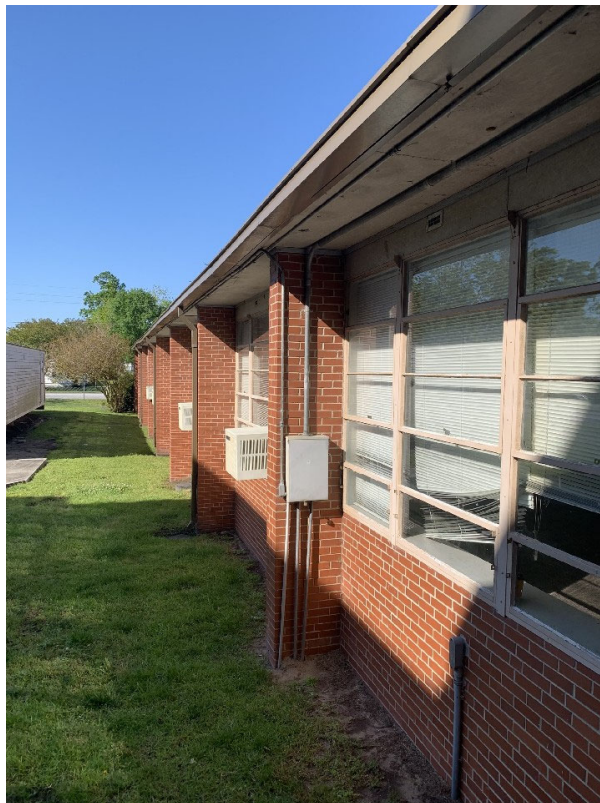
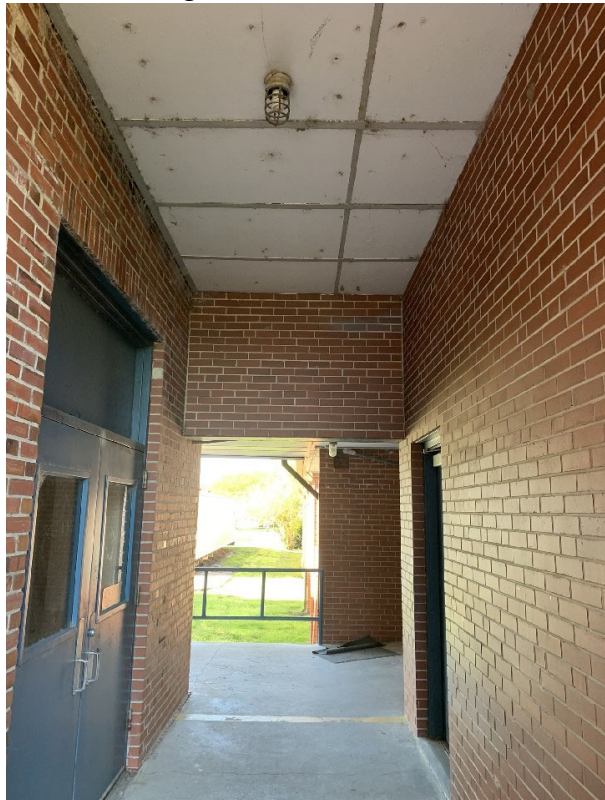
Eave, Building D

025	Glaze	Exterior Window	382 sf	Miscellaneous	Significantly Damaged	Category II Nonfriable	Potential for Significant Damage	4
026	Cementitious Panels	Eave	1100 sf	Miscellaneous	Good (No Damage)	Category II Nonfriable	Potential for Significant Damage	6
027	Membrane	Roof	12550 sf	Miscellaneous	Good (No Damage)	Category II Nonfriable	Potential for Significant Damage	6

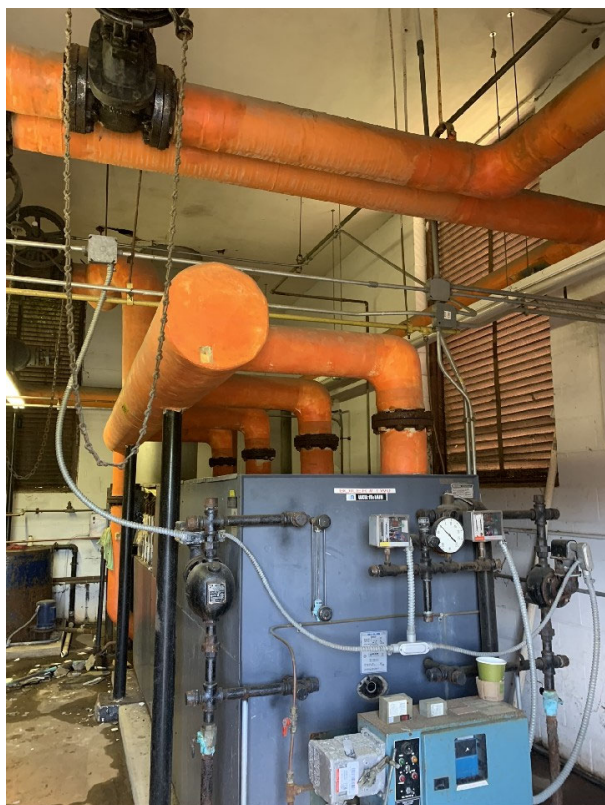
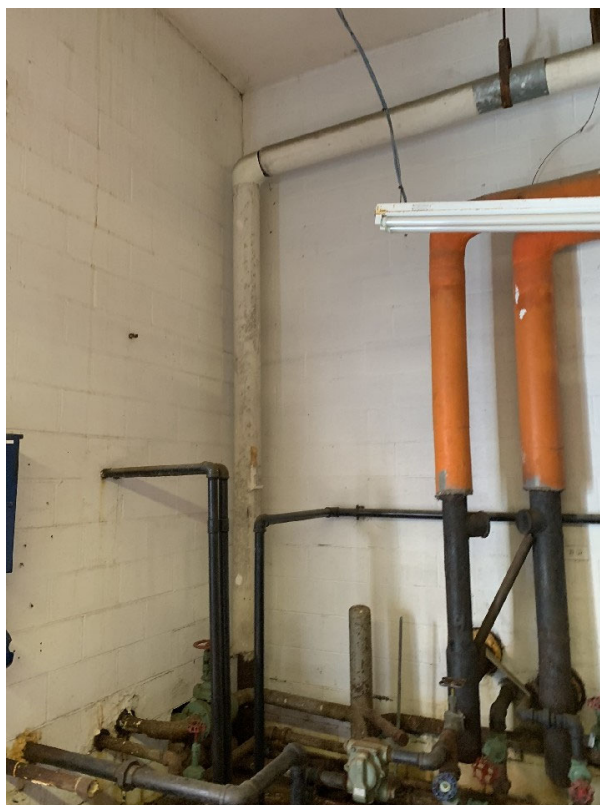
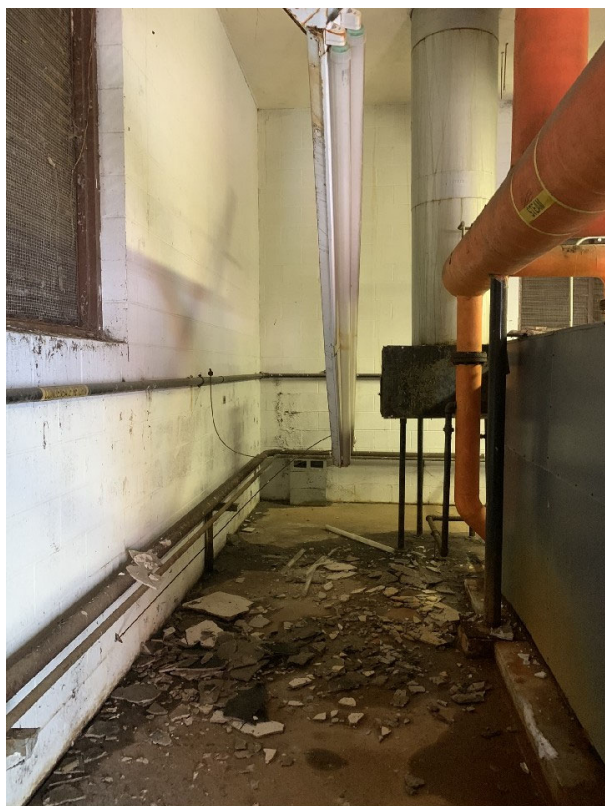
Pipe Wrap, Building F
